**ENVIRONMENTAL MEMORANDUM**

**Red Chris Development Company Ltd.**  
200–580 Hornby Street, Vancouver, BC V6C 3B6

Date: Feb 9<sup>th</sup>, 2016

Re: Red Chris Monitoring Committee Environmental Report Jan 26 – Feb 9<sup>th</sup>, 2016

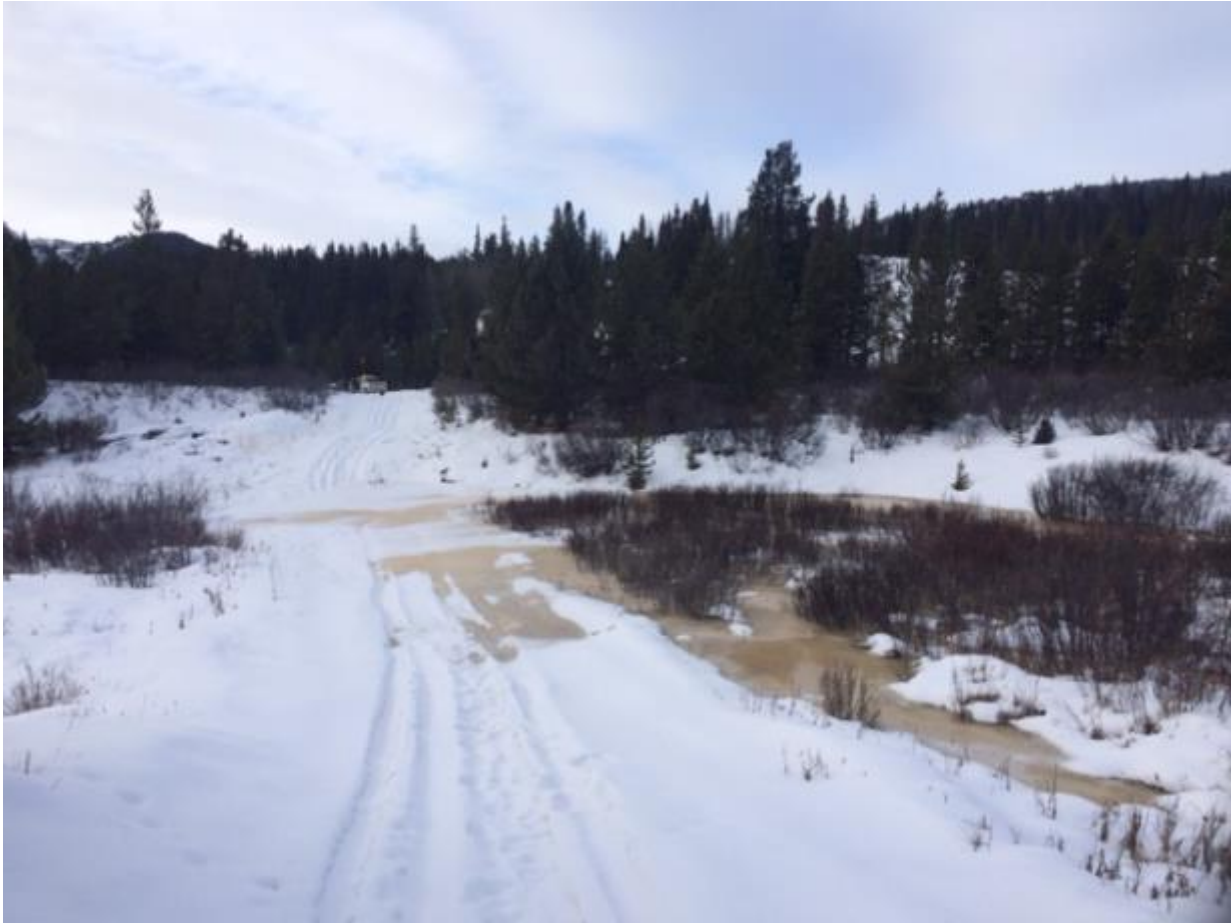
Trail creek just below Black Lake showing untypical stream melting.

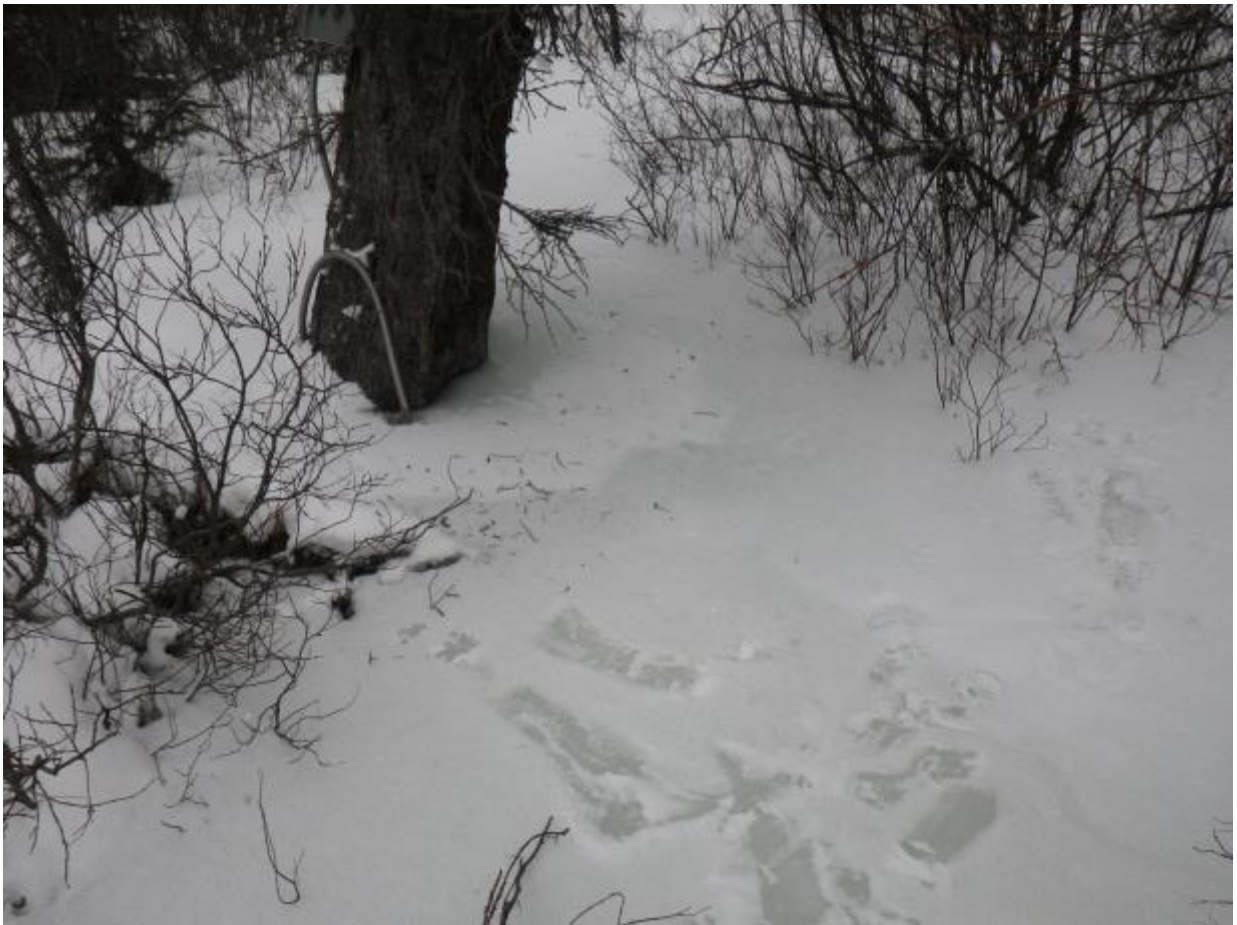
W4 site hydrology station covered in ice over the high water marks of the banks of trail creek.

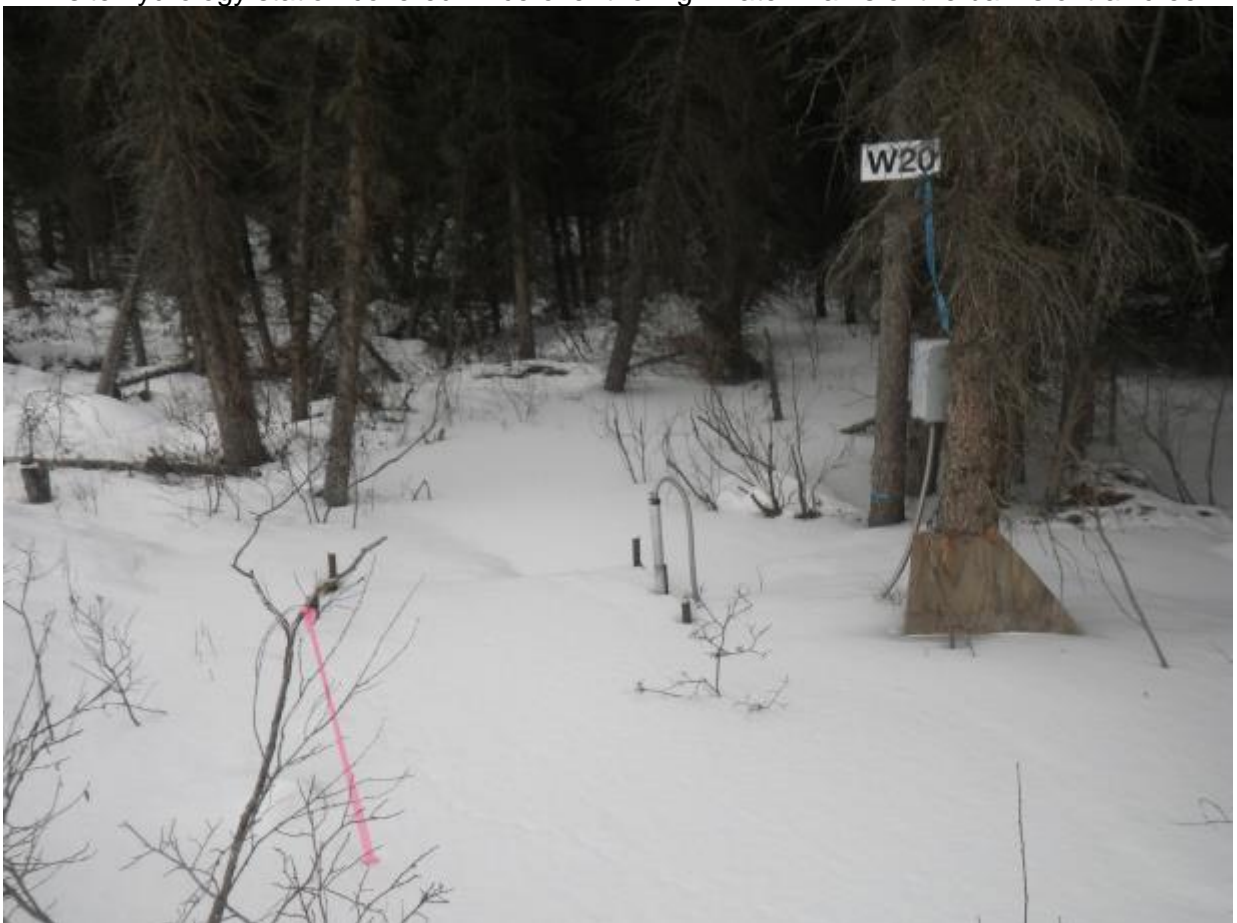
Hydrology station W20 also completely covered in ice over the banks of Quarry creek.

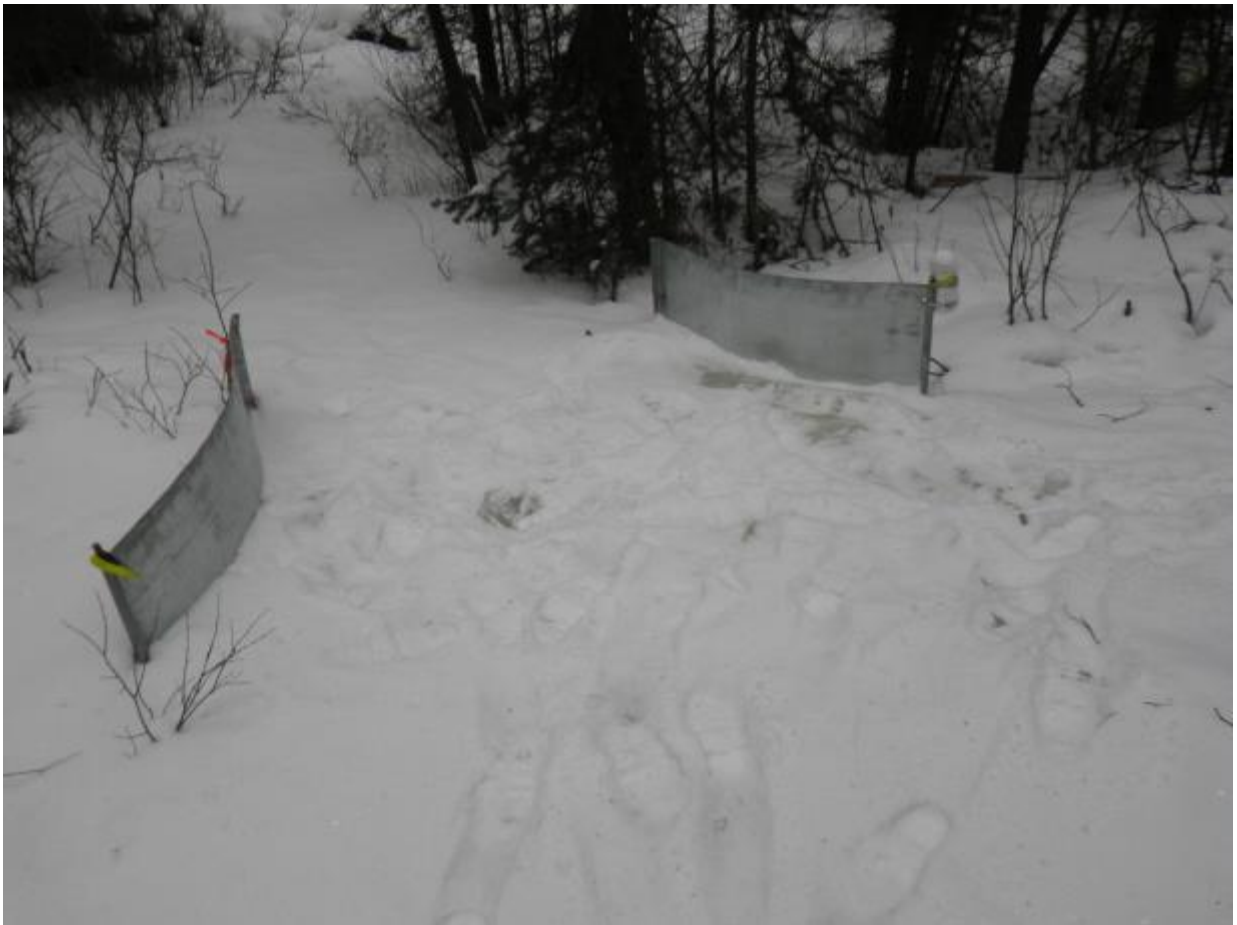
Downstream of W20, the same untypical melting and freezing has occurred at W69 hydrology site, Quarry creek.

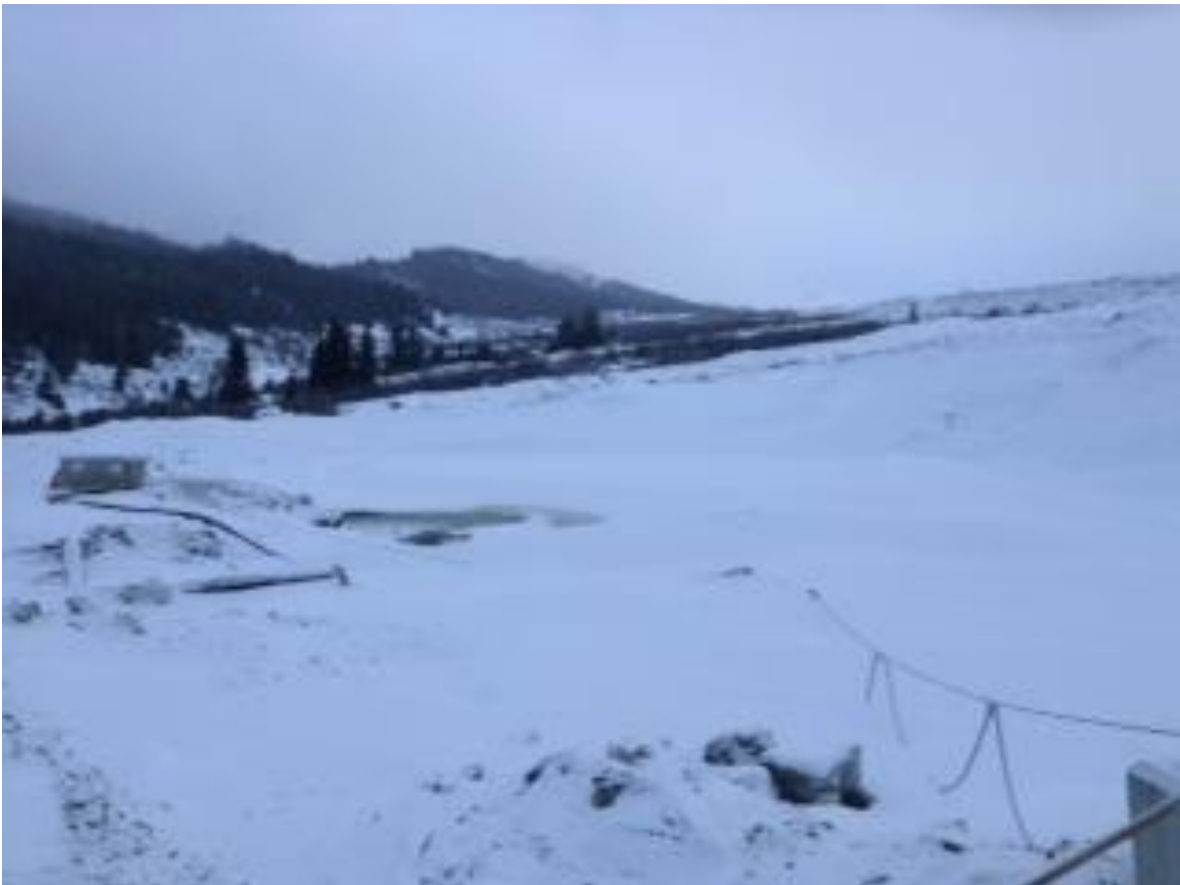
Pit sump (site W75) water levels remain approx. 1.5m below the previous height and no pumping has occurred into it from either the Main or East zone pits.

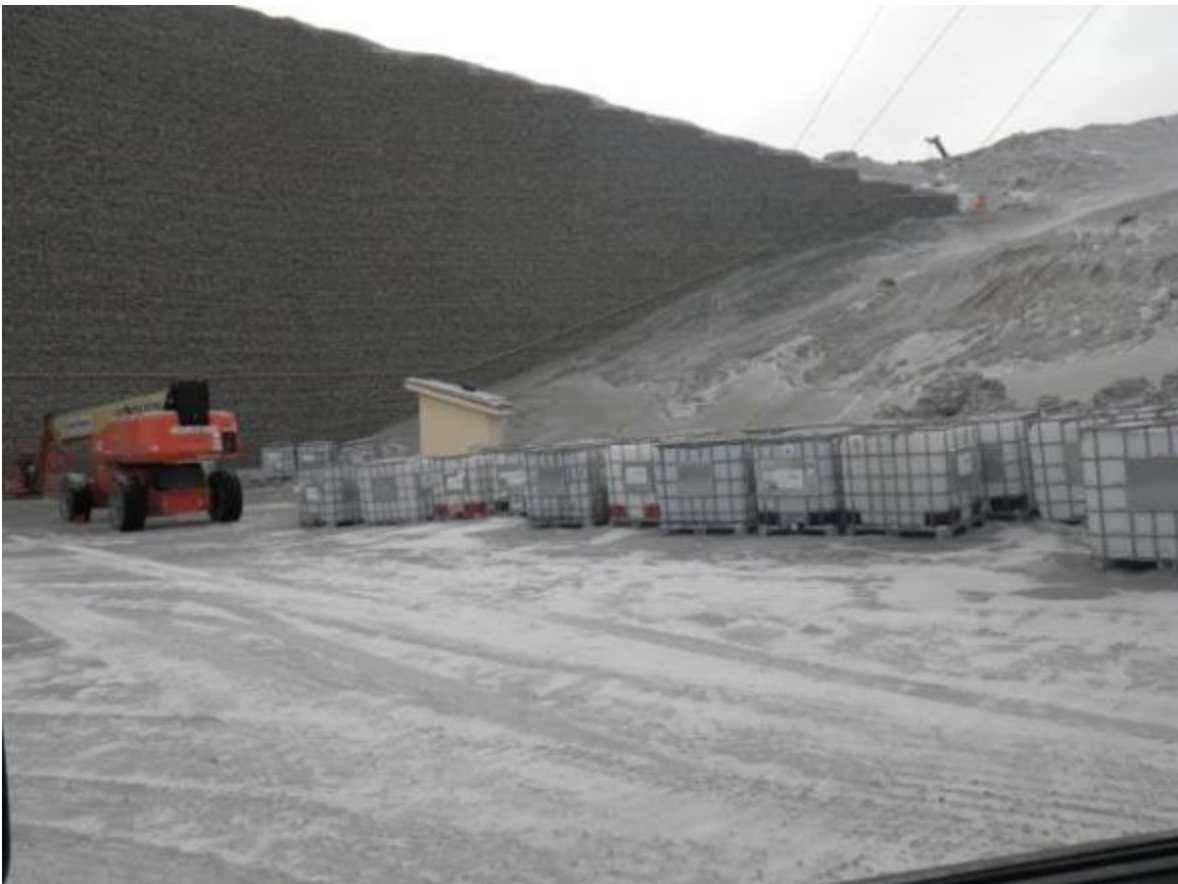
- Spill Feb 1<sup>st</sup> –At conveyor #2 area of conveyor road, A full tote (1,100L) of IPAC was punctured by a zoom boom fork and spilled onto ground. Area was cleaned up and was reported externally to PEP. DGIR#153129. No watercourse or environment outside of the RCDC property was affected. Contaminated soil was properly placed at 18.5km cont. soil area properly. This product is considered environmentally friendly and is not regulated in Canada.

IPAC totes (an environmentally friendly and un-regulated product in Canada) were being stacked near the crusher well and were requested to be placed in a more appropriate location.

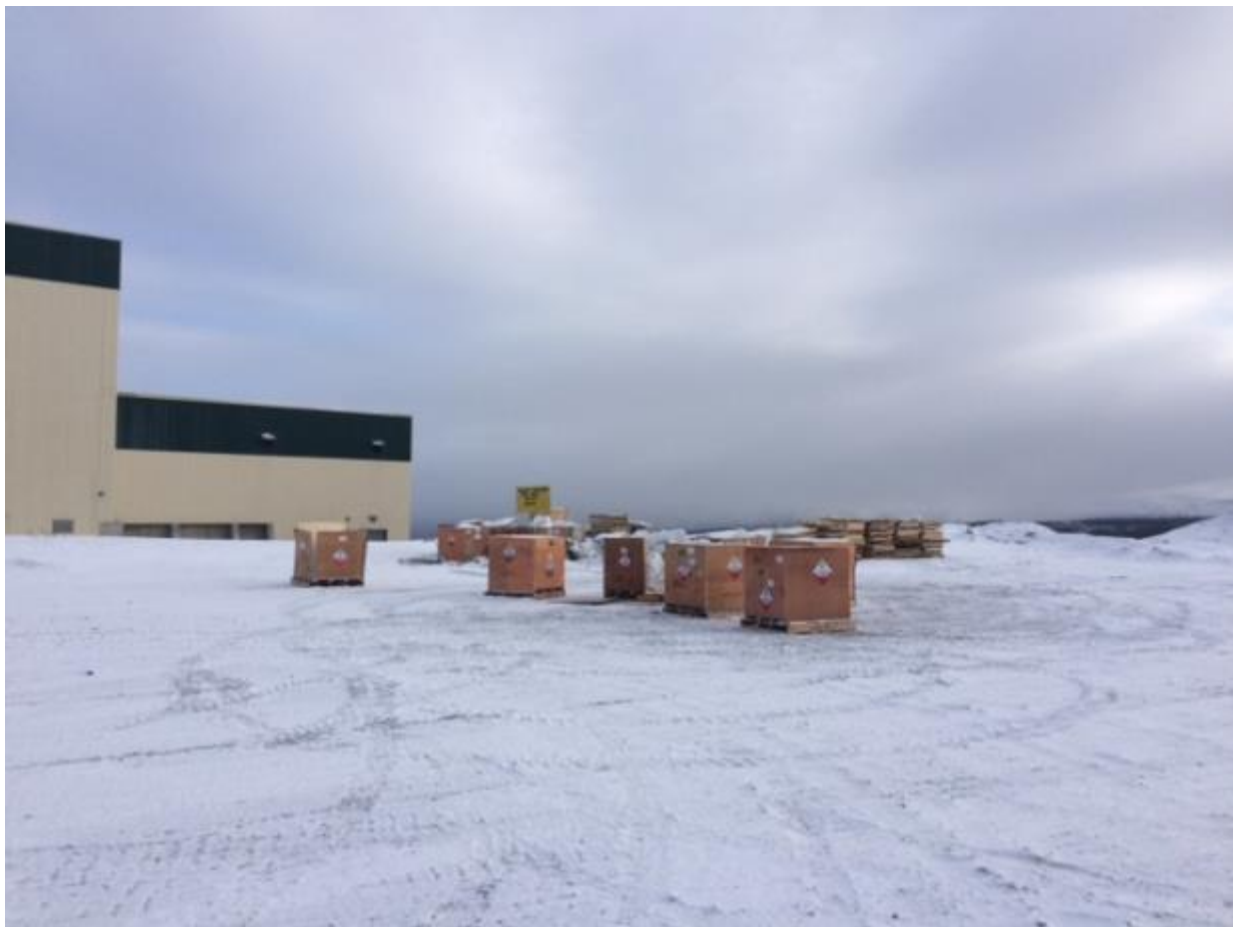
PAX delivery boxes are being used to store the used PAX bags near the mill.

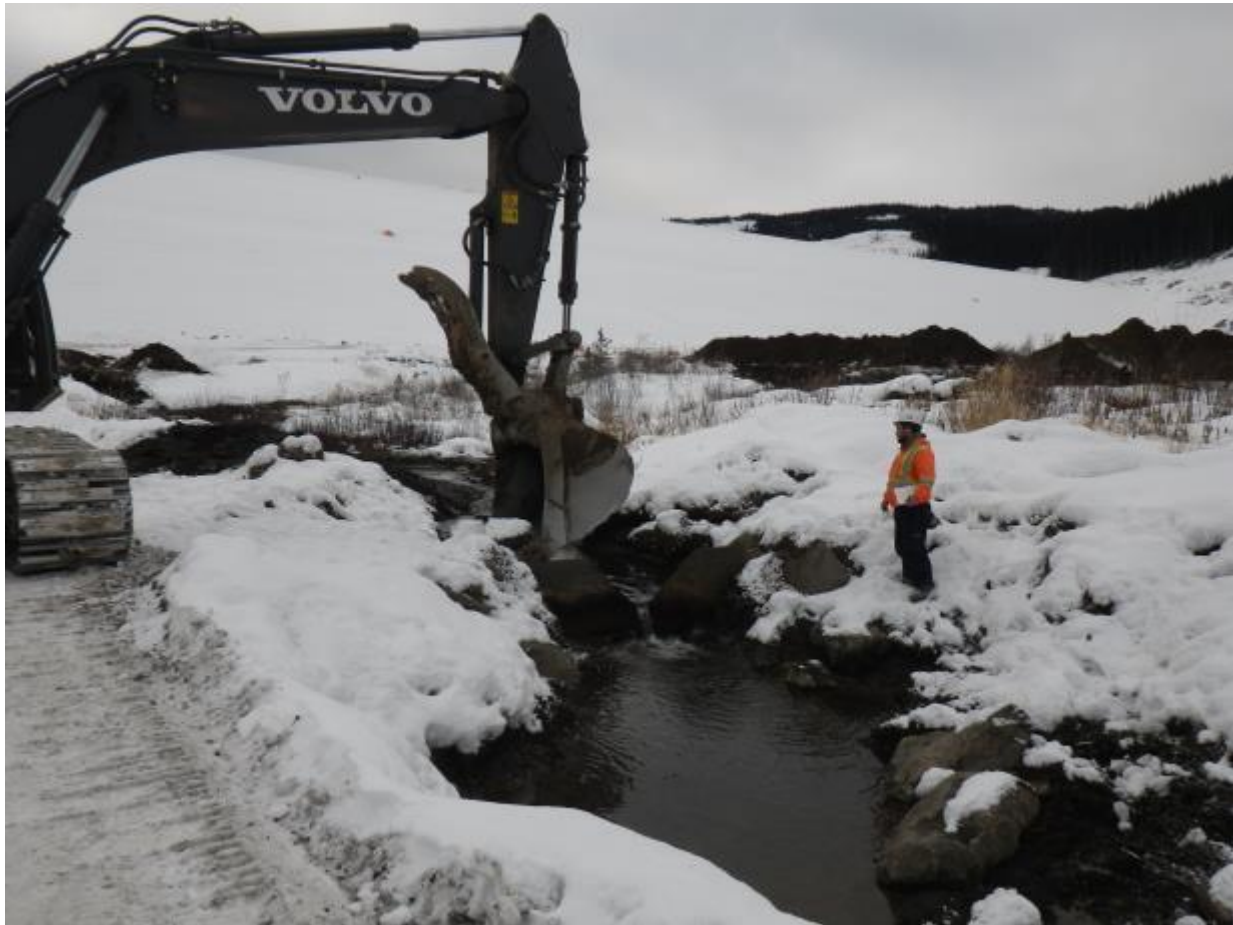
Erosion control on weir 4 to stop the water not flowing through the "V" notch by removing some large boulders directing flows into the bank away from the measuring notch.

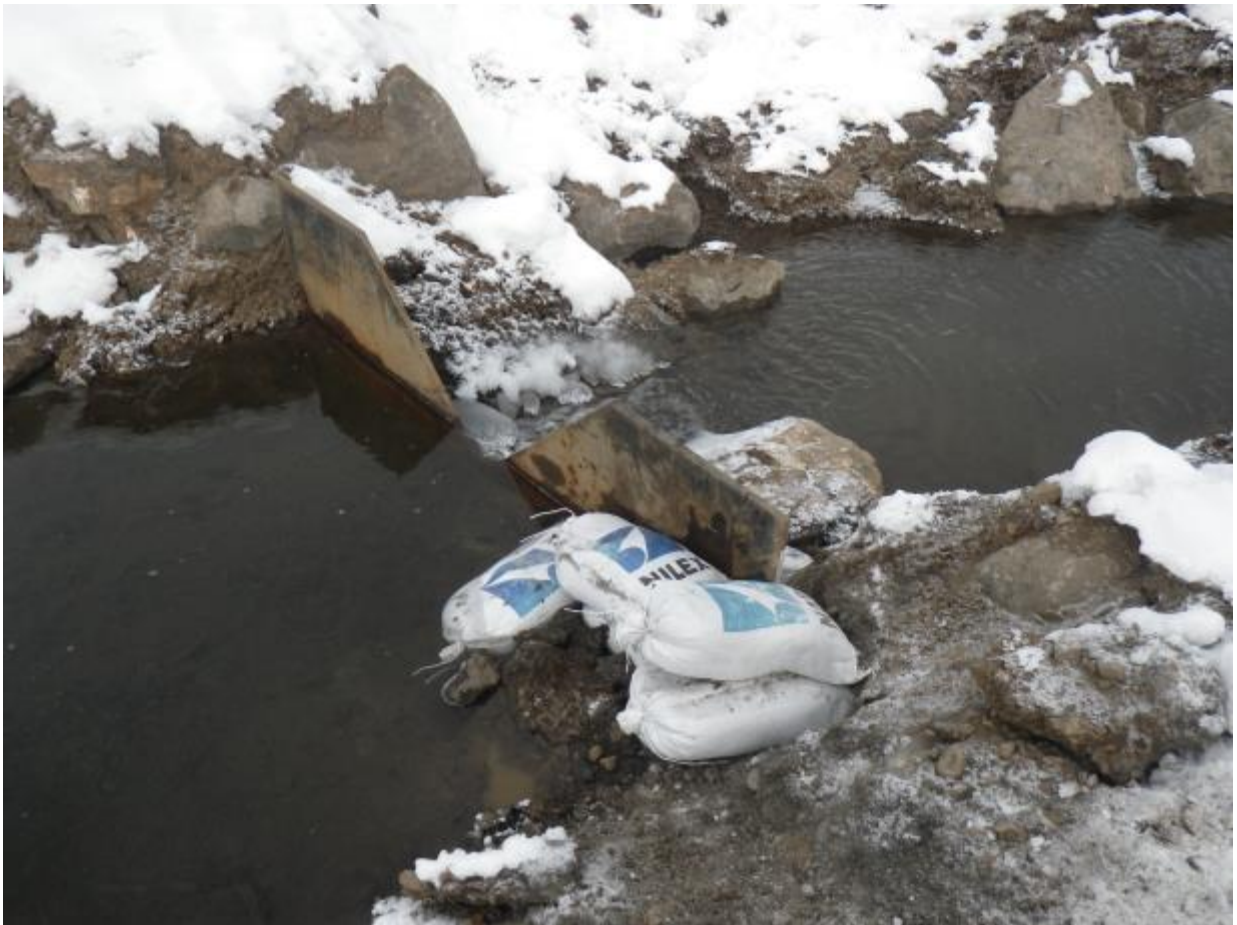
After boulders were removed and sandbags installed, approx. 95% of all the water reaches the "V" notch resulting in the head of the water rising on the staff guage .02m.

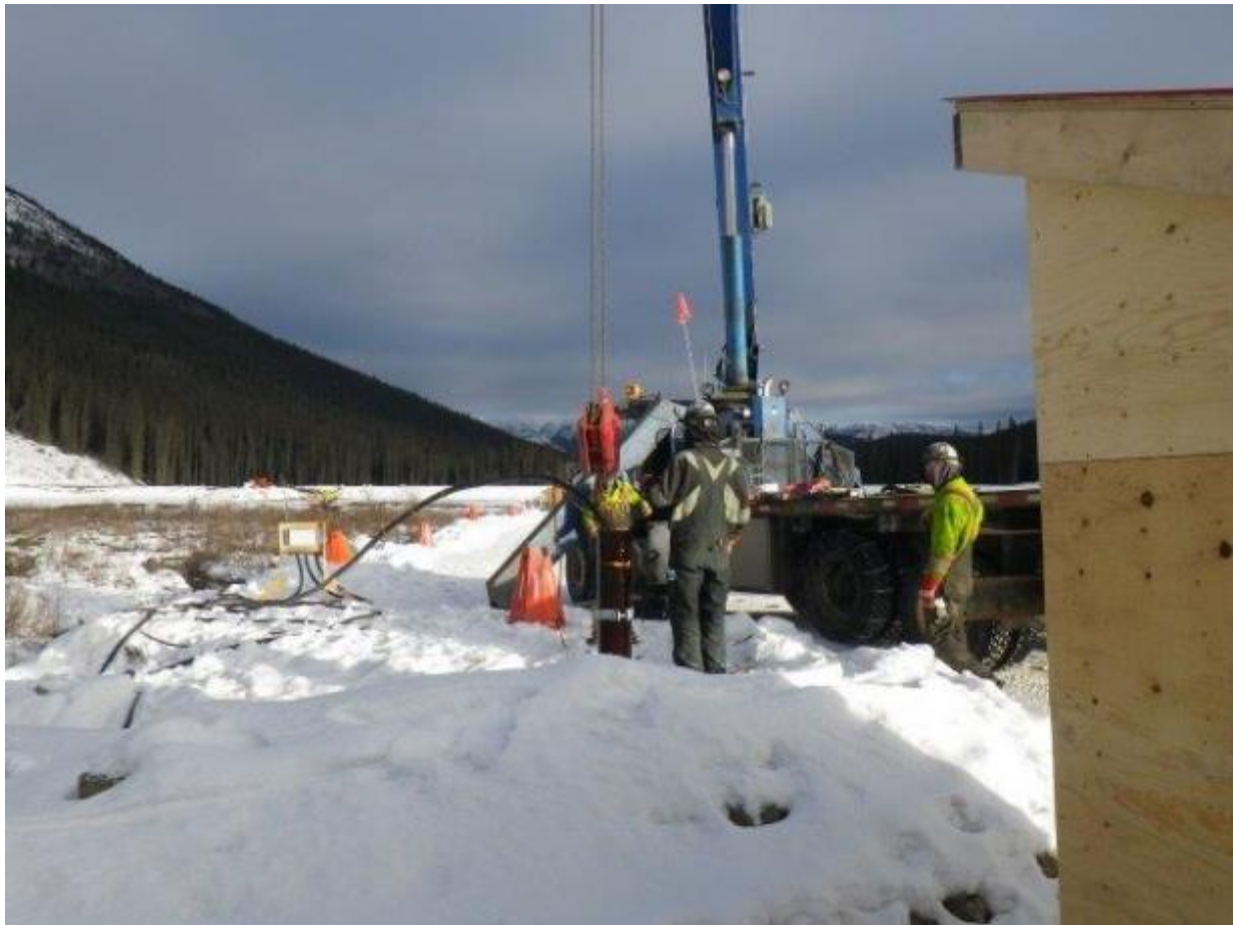
- Additional Pumps are also being installed into groundwater wells WW15-02, MW15-02+MW15-01 intermittently to help reduce saturation of the toe material placement, so as construction activities are not stagnant in 2016. Continued communications between departments is vital in the forward moving progress here. NRD Pond levels will have to be monitored daily to ensure that no release of water flows past the NRD Pond.

Pump installation at WW15-02 to reduce the saturation between the two dams.

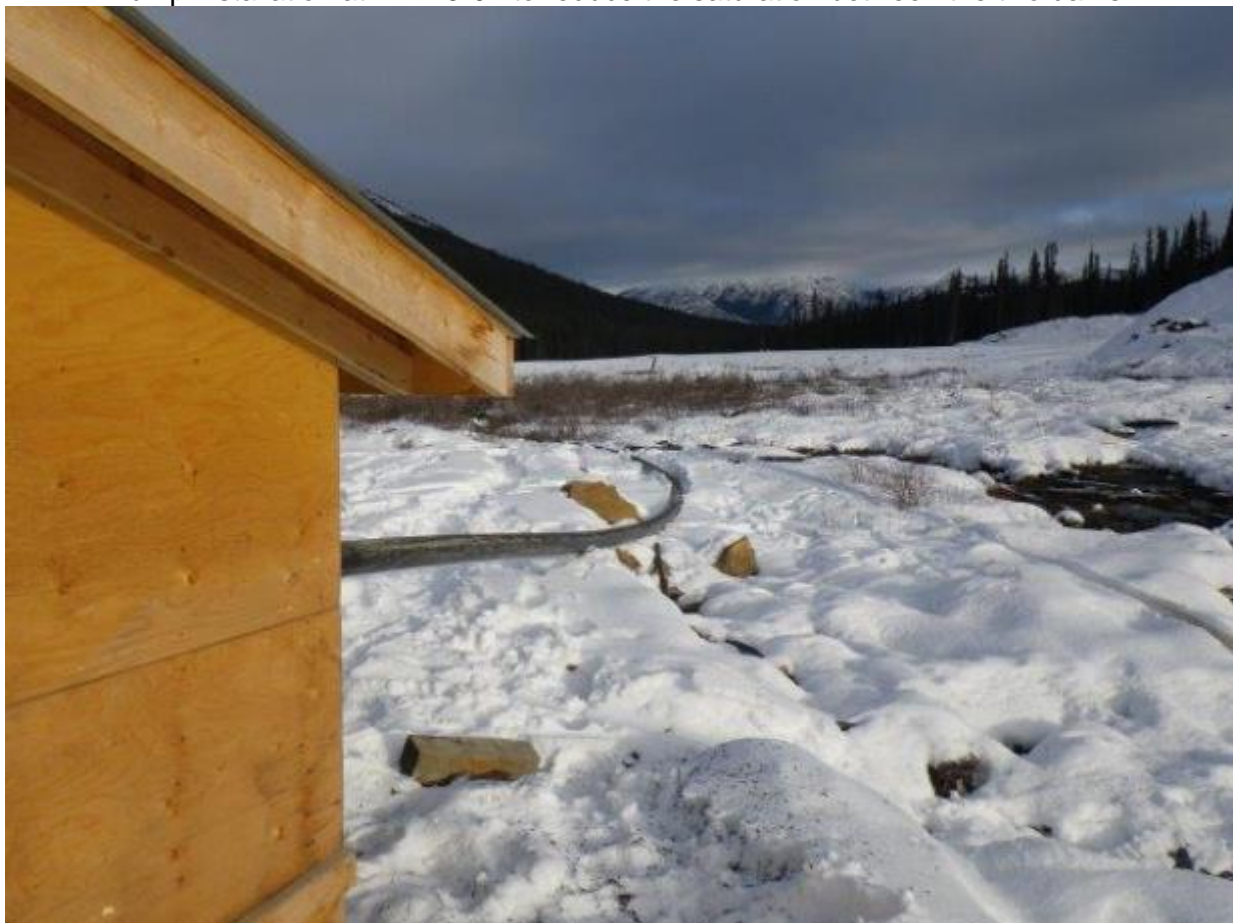
MW15-02 well pump also helped with the saturation.

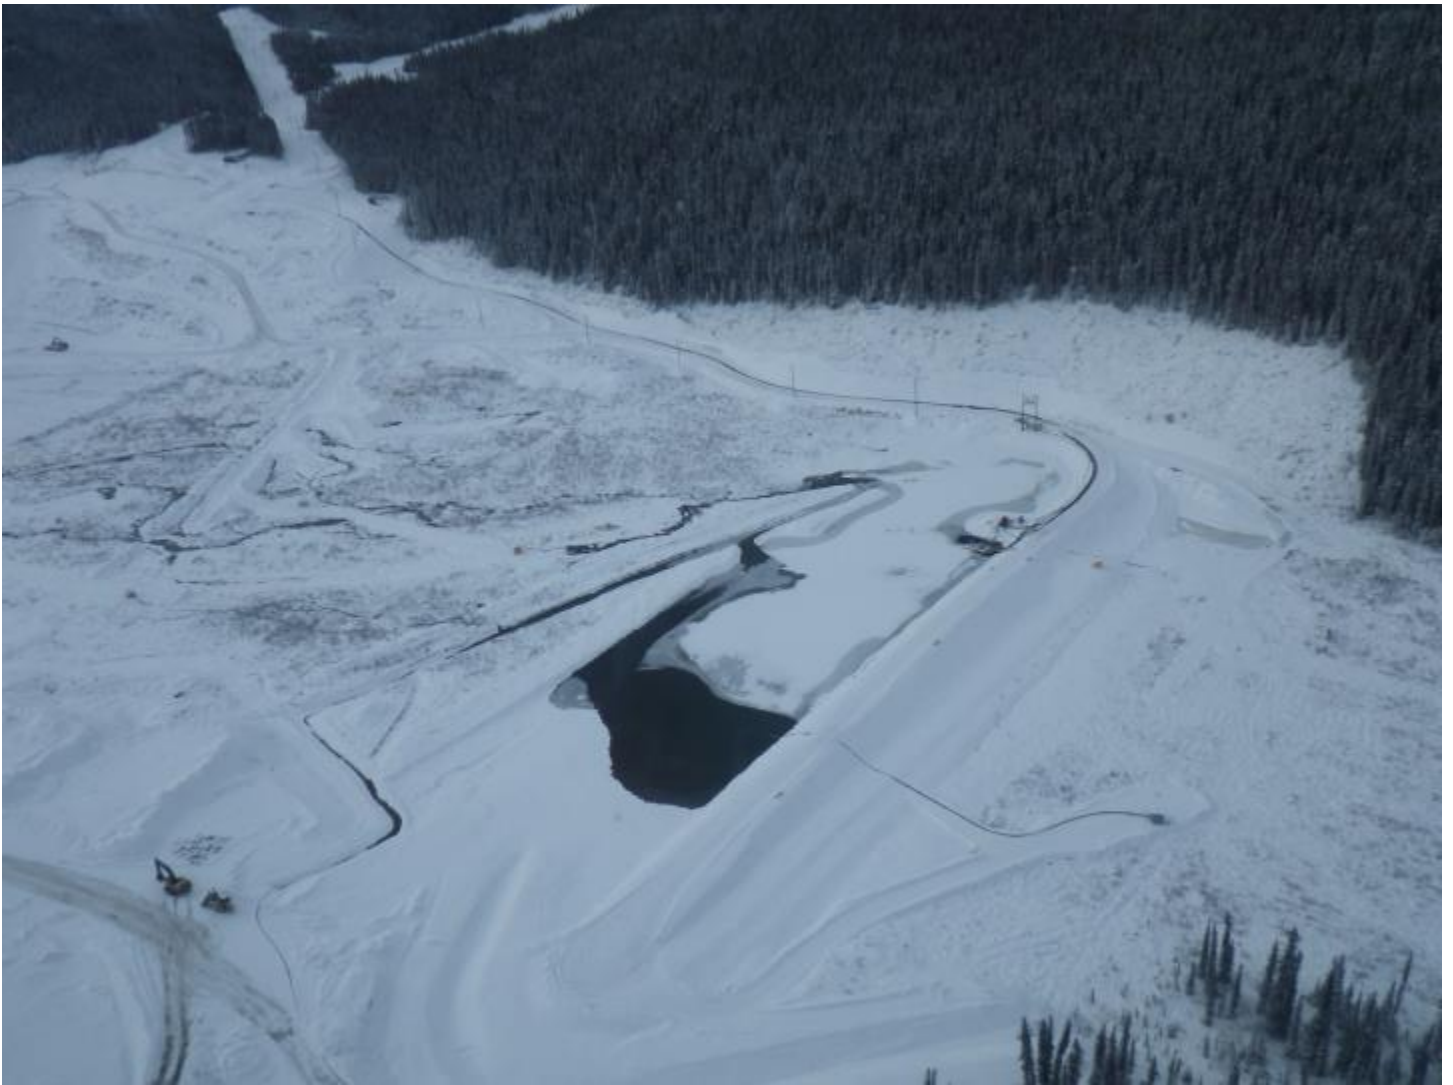
- South TIA road and ditch location being inspected and mapped by survey dept.
- The North Reclaim Dam Discharge weir and channel is full of ice, efforts to remove the ice proved to help for the short term.

North Reclaim Dam showing flow channels of surface water entering the pond.

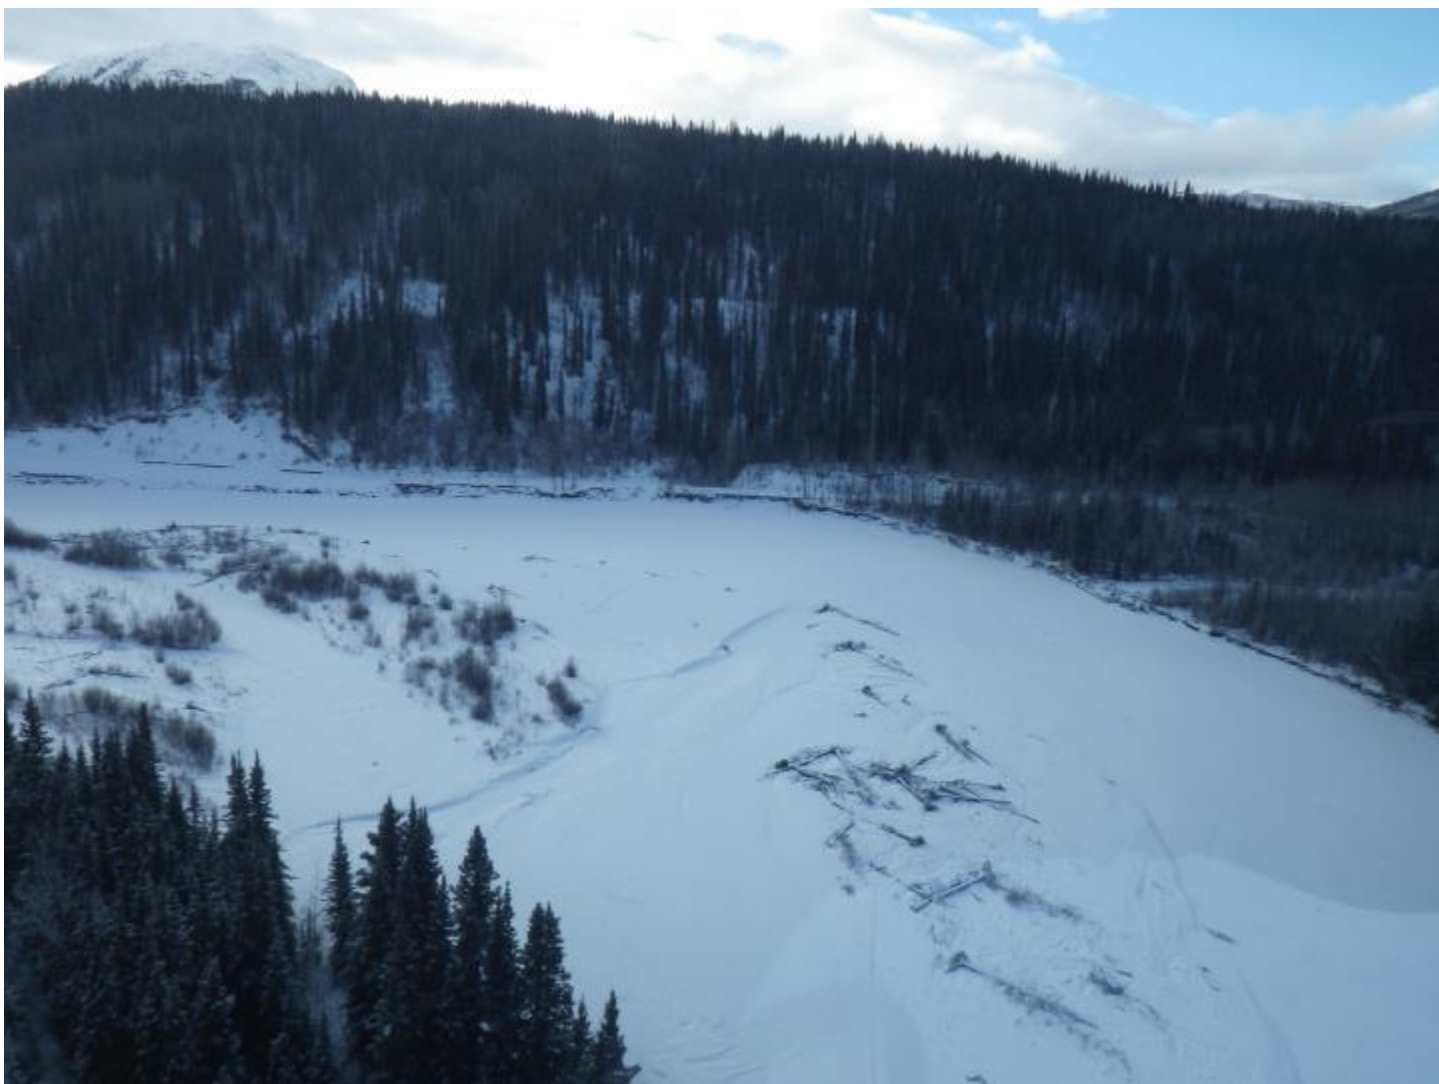
Site W40 was one of many sites that could not provide water during the quarterly surface water samples, here due to the Klappan River being completely frozen.

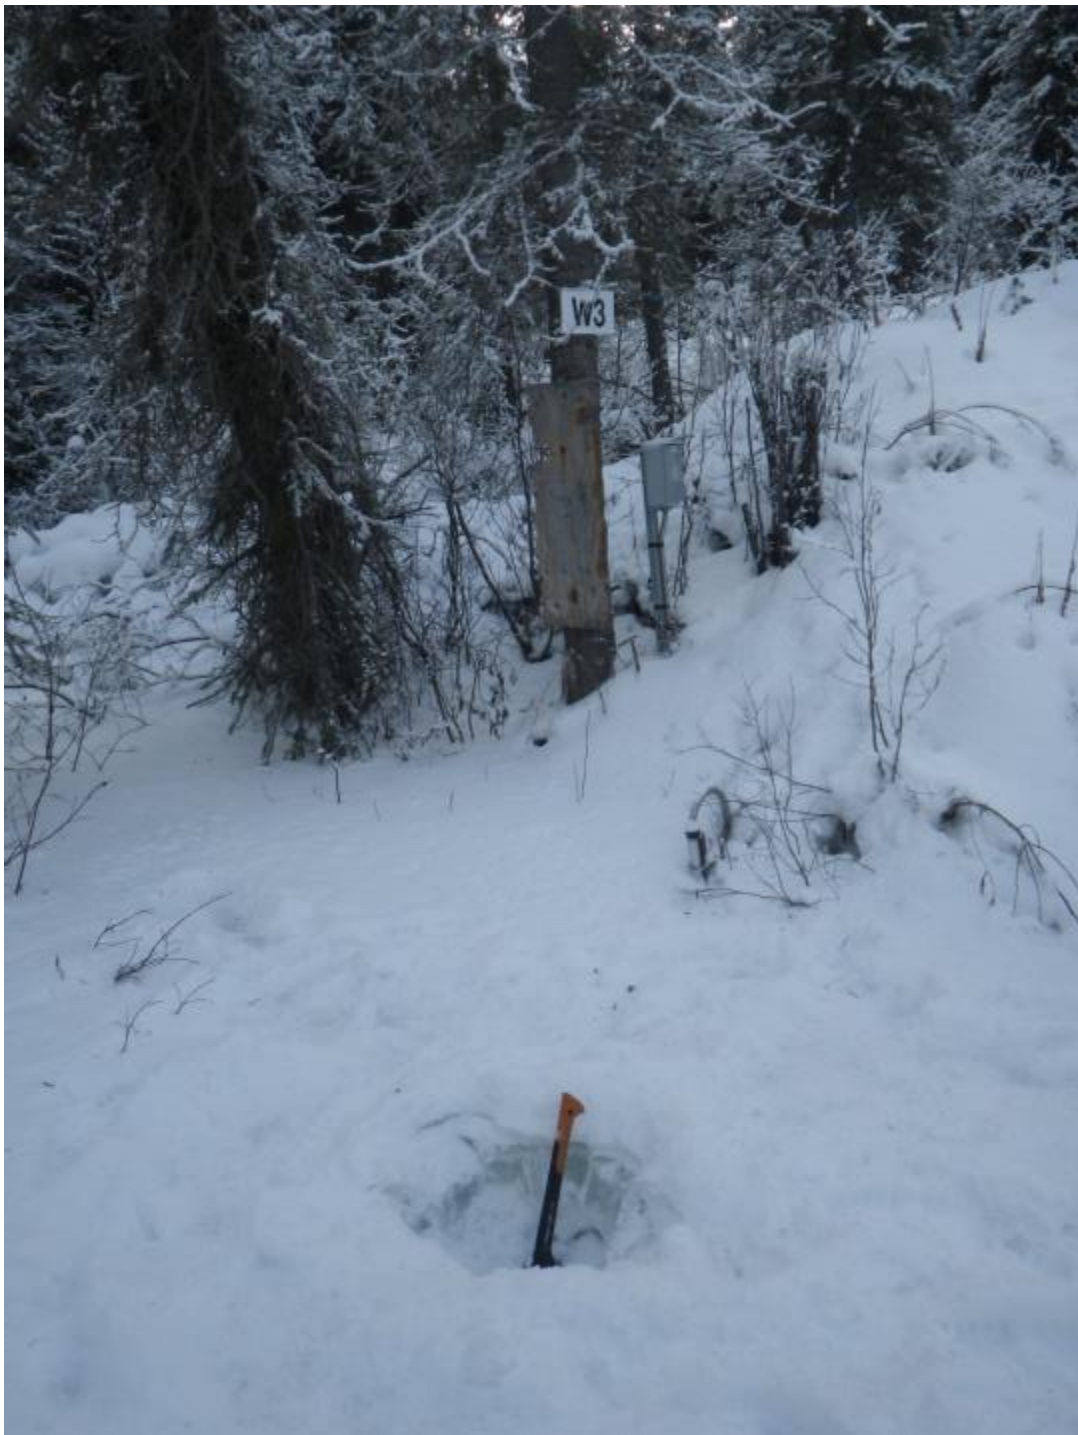
Unusually thick, frozen surface water site W3 on 22.5km of the Klappan road.

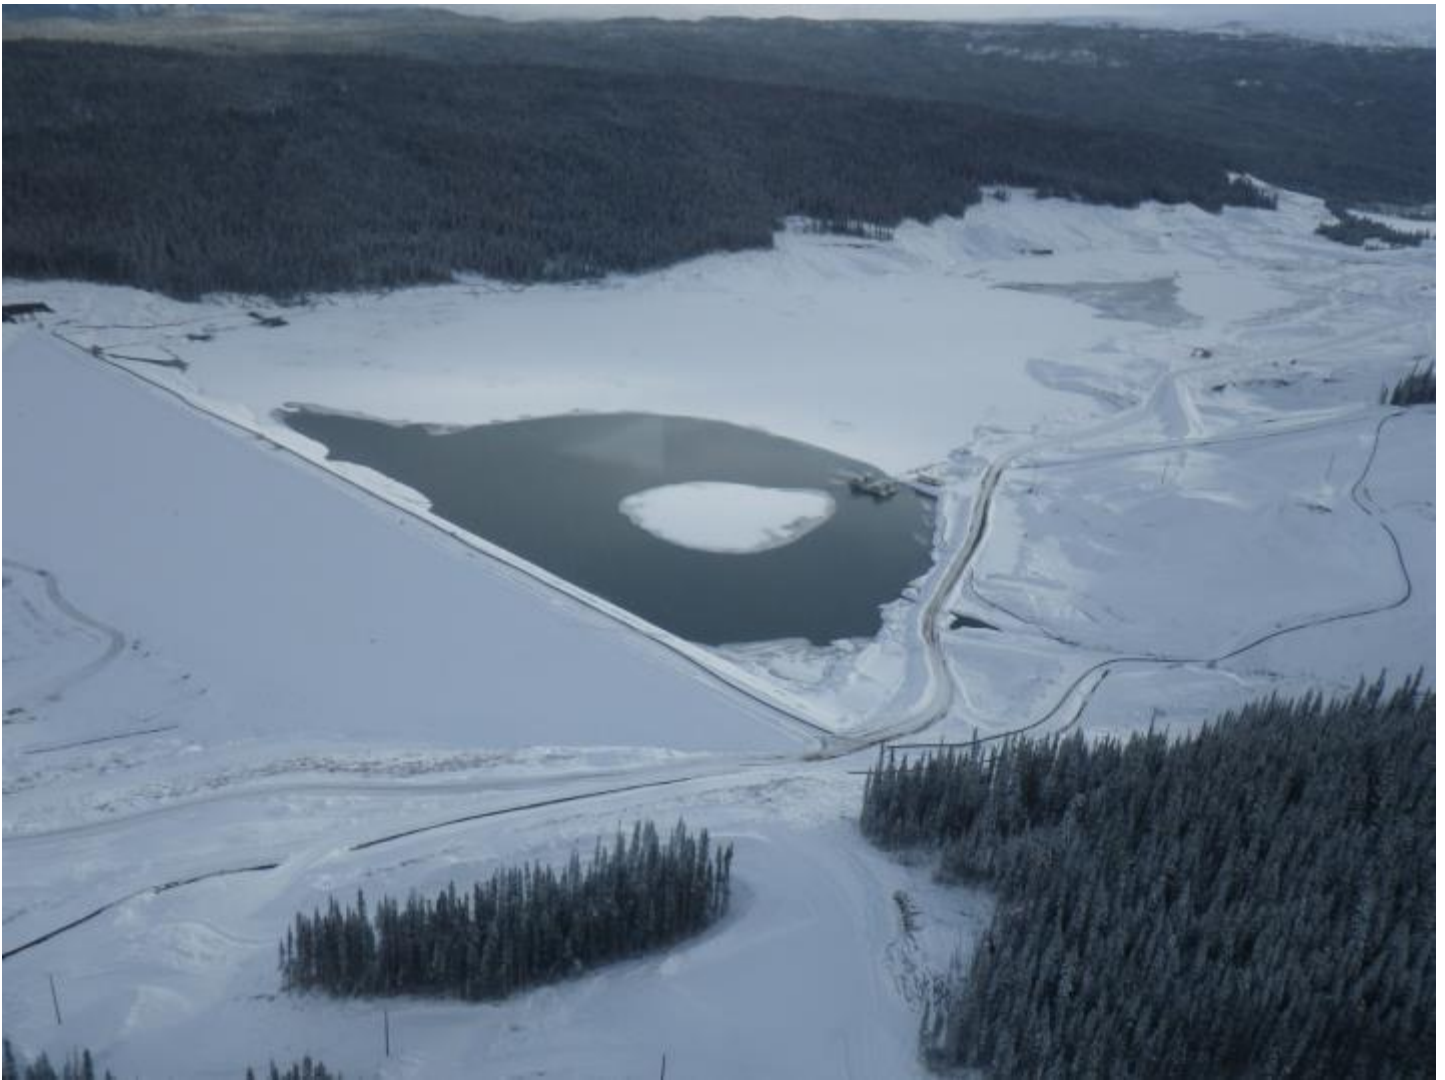
Tailings Impoundment Area water levels are slowly increasing. The dam spans across the left, to the far right is the saddle dam beginning.
